U.S.S. TEXAS (BB-35)

OPTION 6 TANK INSPECTION AND REPAIR ASSESSMENT

Vessel Survey Report No. 2461

Purpose of survey: Option 6 Tank Inspection & Repair Assessment

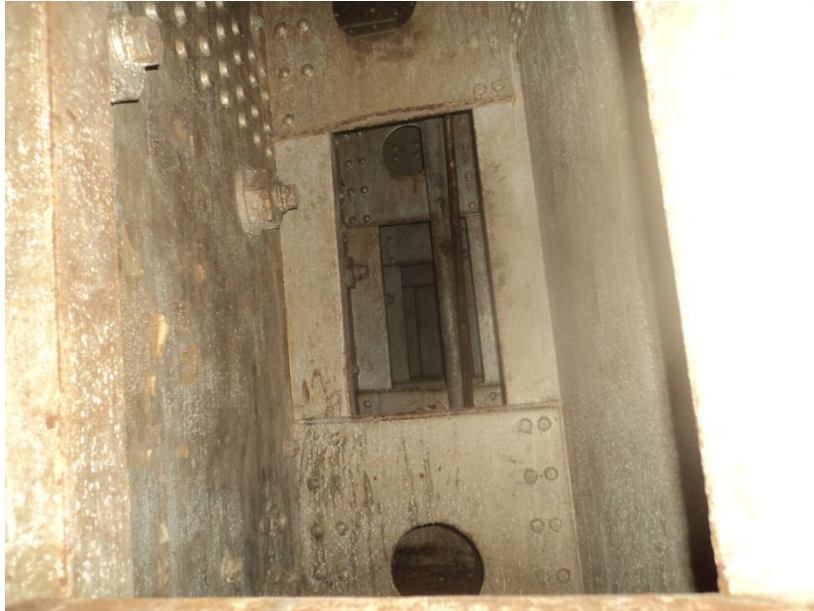
Figure 50. Upper flat of A-91F.

Space is mildly/moderately corroded, but not structurally deficient. Much mold throughout space. Upper tank side shell and scantling degraded 10%, floors 20 -30%. Lower tank side shell and scantlings degraded 30 – 50%, floors degraded 40%. Rivets degraded 20 – 25% in lower flats. Peeling paint and much rust/scale abound. No standing water. This space requires no structural repairs or modifications.

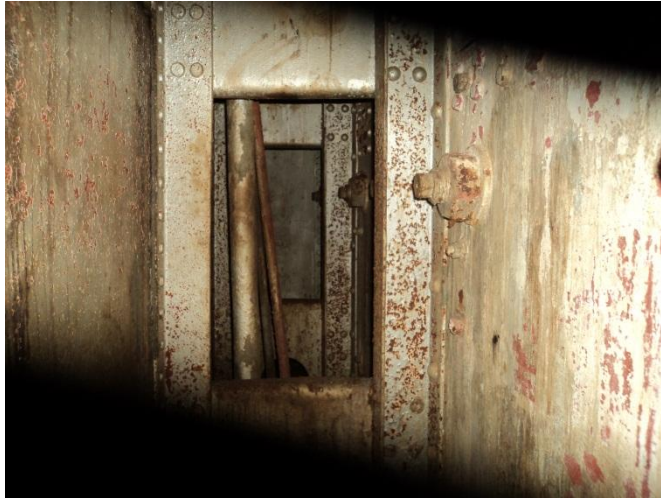
Space is mildly corroded with partially intact paint system on the upper tank and mild/moderate corrosion (25 – 35%) of shell plating and scantlings as one proceeds to tank bottom. No standing water. This space requires no structural repairs or modifications.

Figure 52. General good condition of B-25S.

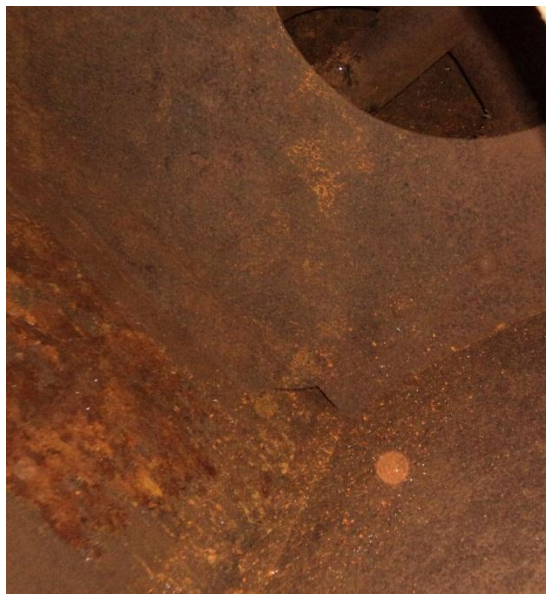
Space is moderately corroded, but not structurally deficient. Upper tank side shell and scantling degraded 25%, floors 20 -30%. Lower tank side shell and scantlings degraded 30 – 40%, floors degraded 40%. Rivets degraded 20 – 25%. Peeling paint and much rust/scale abound. **3' standing water/oil.** This space requires no structural repairs or modifications.

Figure 53. Shell plating at turn of the bilge in B-73F.

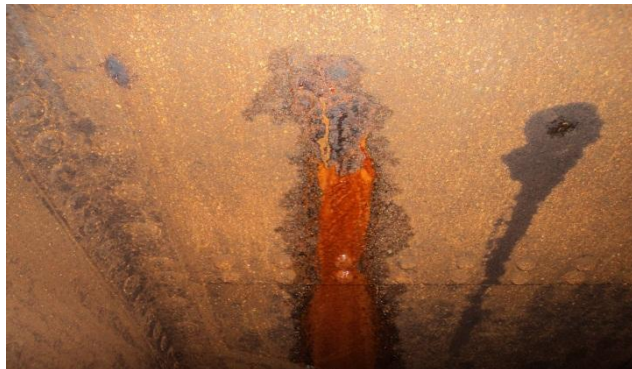
Figure 55. Leaking shell plating from blister tankage in B-77F

Ensure dewatered blister tankage outboard and insert 12" x 24" 3/4" A-36 mild steel doubler patch on lower side shell plating.

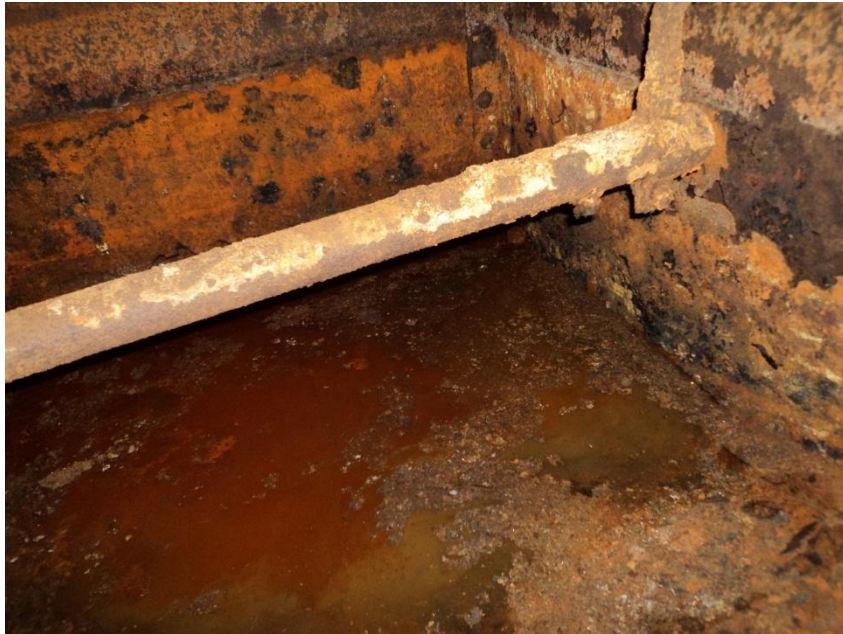
Figure 56. Standing water/oil and deteriorated structure in B-77F.

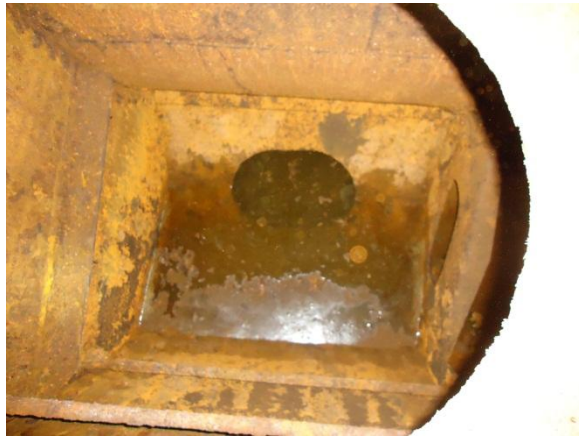
Figure 58. Standing water at turn of bilge in B-79F

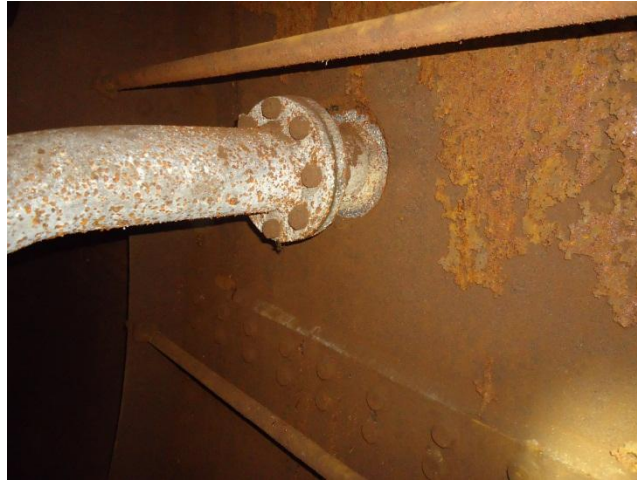
Figure 62. Piping into blister tankage through side shell plating in B-85F.

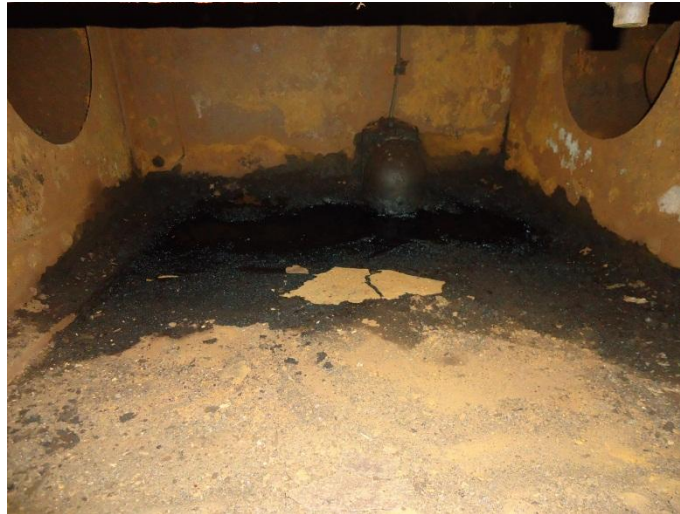
Figure 64. Black oil resting on tank bottom in C-81F.

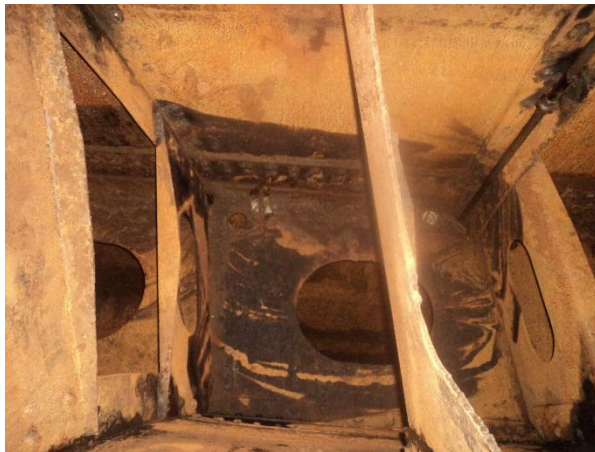
Figure 75. Intermediate flat in D-91F showing effects of oil seepage.

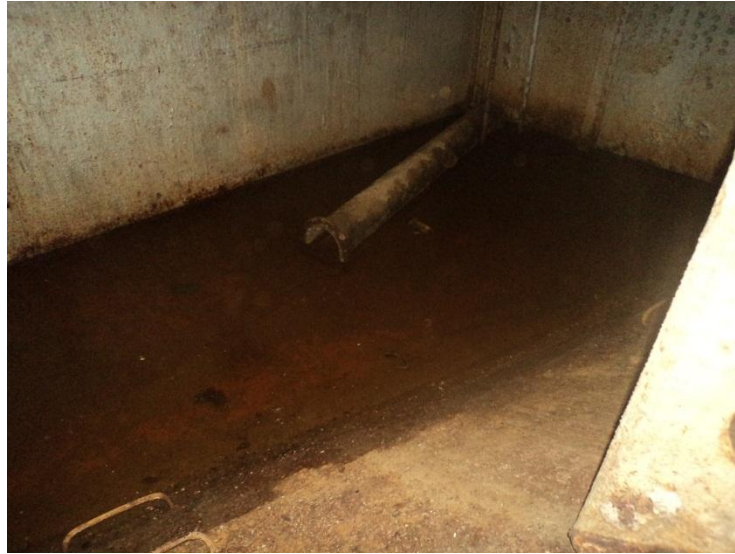
Figure 76. Bottom of tank showing standing water in D-40S.

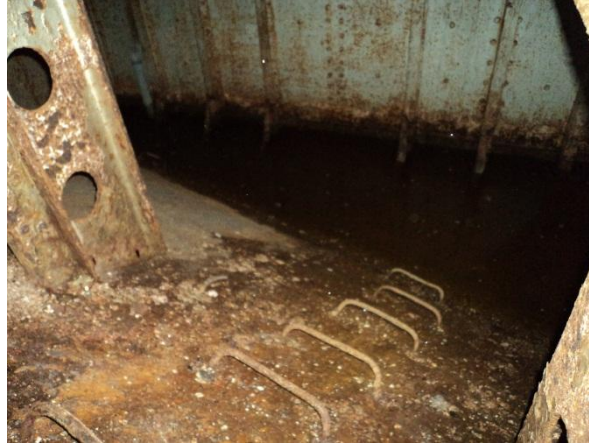
Figure 78. Bottom of tank showing standing water in D-41S.

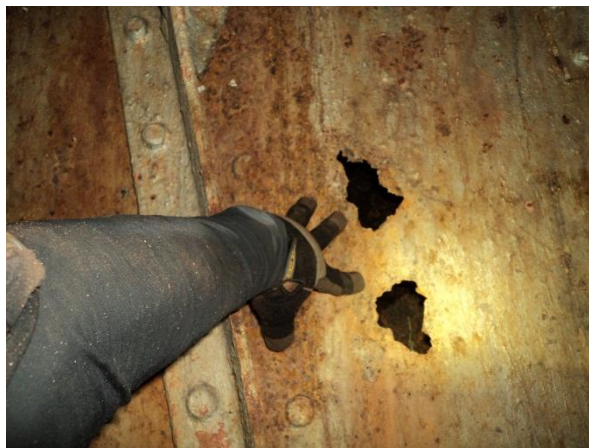
Figure 79. Wasted shell plating on lower exterior in tank D-93V.
